Manhole Inspection Summary

Manhole # S55A2_002MH

Location Address: **3501 Asiatic Ave.**

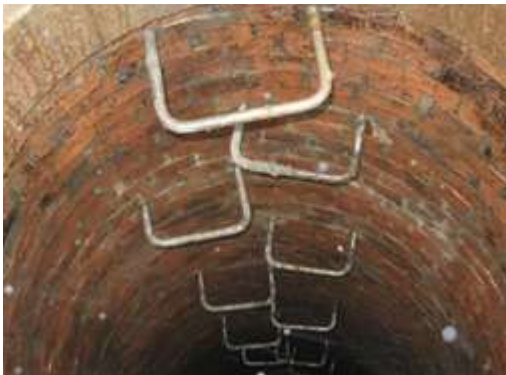
Steps

Count: **11** Missing: **0** ☐ Corroded

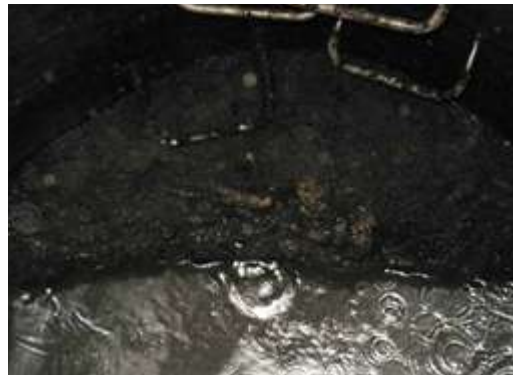
Defect 1

Dirt covering bench

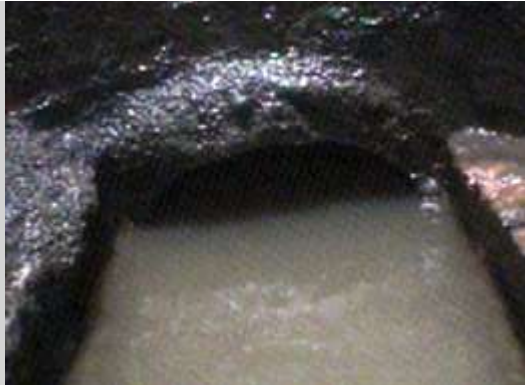
12 O'Clock Outflow

24 in. Circular Gravity Sewer
Pipe Out @ 12 O'Clock

Pipe Height: **24** (in.) Rod and Bar (Angled)
Pipe Material: **Unknown** ☐ Pipe Lined
Invert Depth: **18.30** (ft.) Flow Characteristics: **Slow**
Deposits: ☒ None ☐ Mud ☐ Sludge ☐ Debris ☐ Grease
Silt Depth: (in.) Deposits Extent:
Infiltration: **None** Pipe Seal Cond: **Sound**

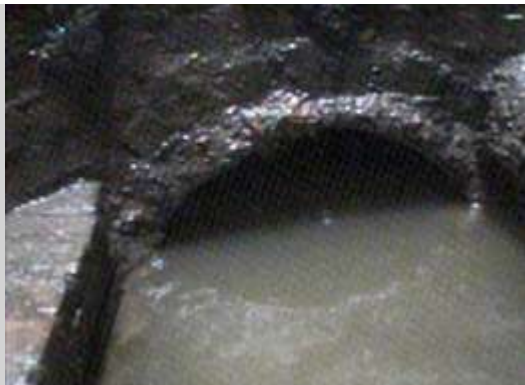
6 O'Clock Inflow

24 in. Circular Gravity Sewer
Pipe In @ 6 O'Clock

Pipe Height: **24** (in.) Rod and Bar (Angled)
Pipe Material: **Unknown** ☐ Pipe Lined
Invert Depth: **18.26** (ft.) Flow Characteristics: **Slow**
Deposits: ☒ None ☐ Mud ☐ Sludge ☐ Debris ☐ Grease
Silt Depth: (in.) Deposits Extent:
Infiltration: **None** Pipe Seal Cond: **Sound**
